7th and 8th Generation Intel® Core™ Processor Family

Specification Update

November 2019

Revision 011

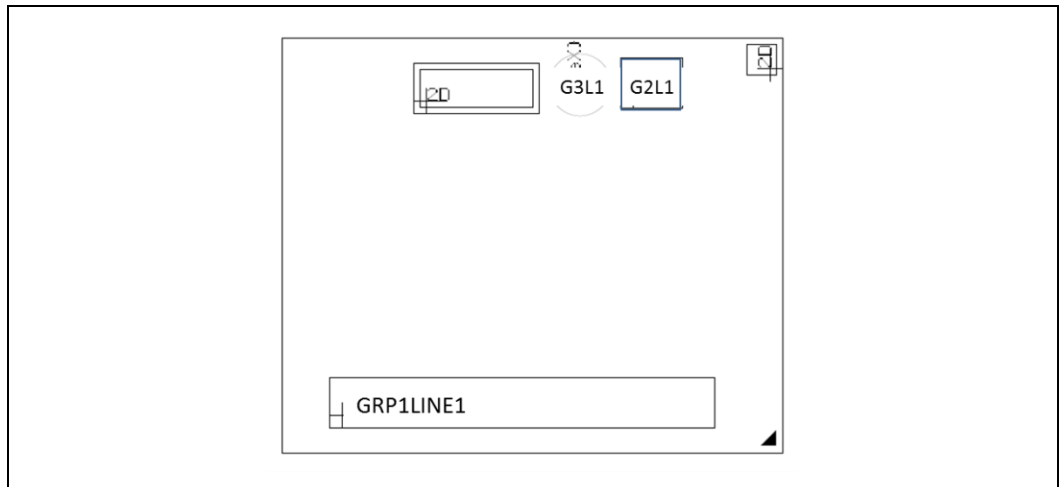
Figure 6. Y22-Processor Line Multi-Chip Package BGA Top-Side Markings

Pin Count: 1515

Package Size: 20.5 mm x 16.5 mm
